# CAF<sup>®</sup> CASE STUDY

## Automotive Paint

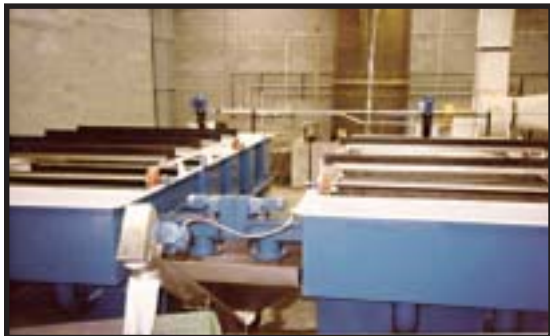
*The two CAF-75 units operating side by side.*

Hydrocal installed a CAF system, which proved very effective and simple in removing paint sludge from the shower curtain water.

The three units were so successful in cleaning the paint booth recycled process water that within twelve hours automatic timers were installed. The units now run on automatic cycle intermittently 24 hours a day.

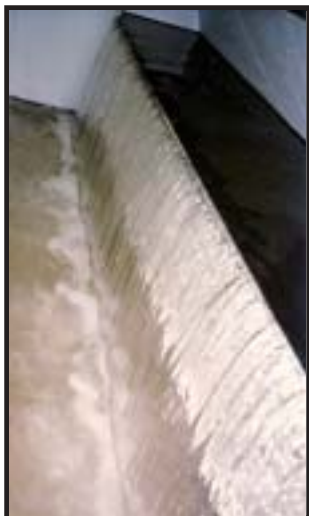
*Clarified effluent.*

<b>Influent</b>	<b>500-1000 ppm</b>
<b>Effluent</b>	<b>10-15 ppm</b>
<b>% Removal</b>	<b>98.5 %</b>
