CAF® CASE STUDY

Egg Processing

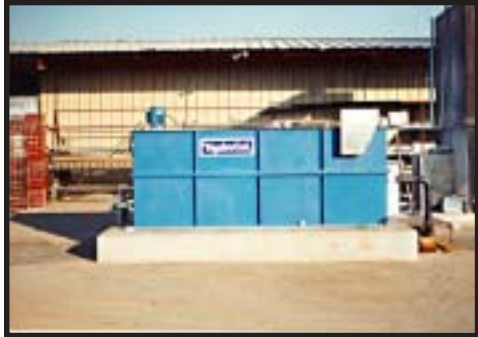
CAF unit installed at an egg ranch/plant.

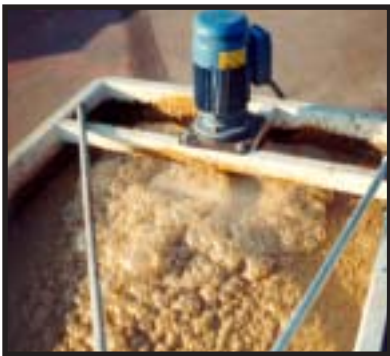
A thick layer of solids floating on the surface prior to discharge.

The mixture of broken eggs and wash water is discharged to a balance tank and then sent through a settling clarifier. The settling clarifier, however, was not meeting the new EPA regulations.

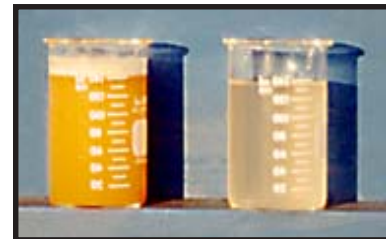
Before After

CAF Performance		
	<u>Influent</u>	<u>Effluent</u>
Gallons per day	30,000	27,800
pH Adjustment	11.0	7.0
Suspended Solids	2,200 ppm	20 ppm
Chemical Cost Per Day = \$20.00

Clear Effluent

Hydrocal's scheduled a trial, which immediately demonstrated that the CAF unit would achieve results well within the new regulations and a unit was installed.
