CAF[®] CASE STUDY

Potato Processor

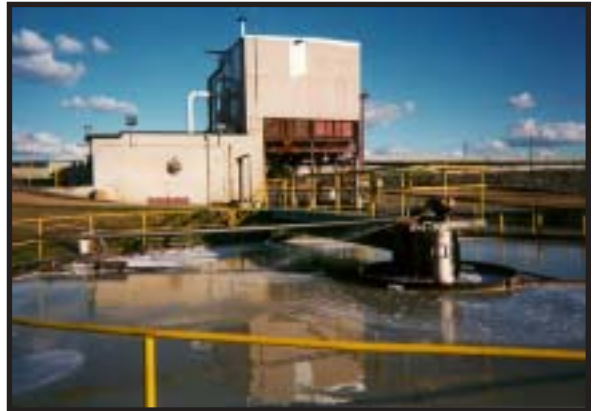
The CAF, housed in the building behind the clarifier, was installed to improve the clarifiers performance.

After reviewing their wastewater treatment process, the source of their problems was identified as a high strength recycle stream, comprised of filtrate and spray bar water from the vacuum drum filters. This stream was being returned to the clarifier and causing the strong odors and significant impacts on the land treatment system.

After the CAF installation, both the odor and land application problems were solved. The HydroCal CAF unit successfully treats the recycle stream from the de-watering equipment, achieving consistently high reductions in total suspended solids, BOD and oil & grease levels. The elimination of high strength recycle streams from the process enabled the treatment system to function as originally designed.
