CAF[®] CASE STUDY

Tannery

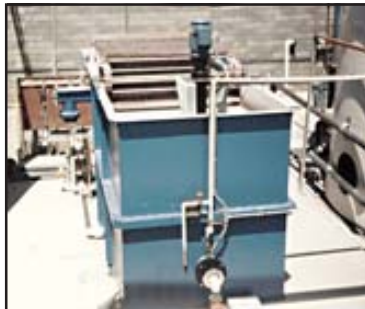
Model CAF-25 installed in a tannery.

Hydrocal performed pilot tests at several facilities and excellent results were obtained. The main challenges encountered were balancing the flows and controlling pH levels. HydroCal easily solved these problems and installed a CAF system to treat the wastewater.

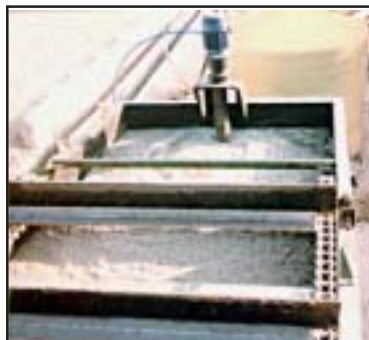
Solids floating on the surface.

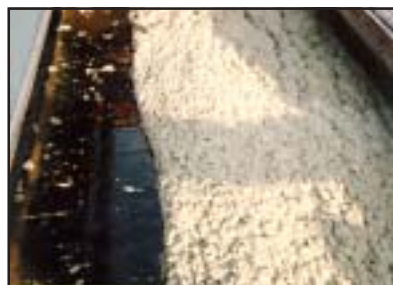
Sludge being discharged into a screw conveyor.
